**Analysis of
H2 related incident and
accident database
HIAD**

Thomas JORDAN
(Head of H2 Group of IKET/KIT)
Leader of Task Force TF1
European Hydrogen Safety Panel
EHSP

HRS Workshop H2ME

Den Haag, The Netherlands, 26 November 2019

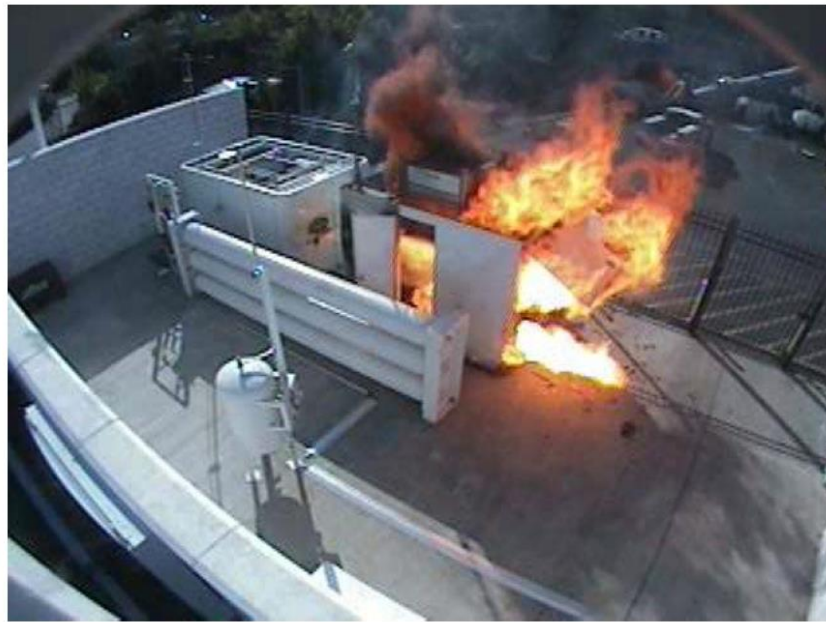
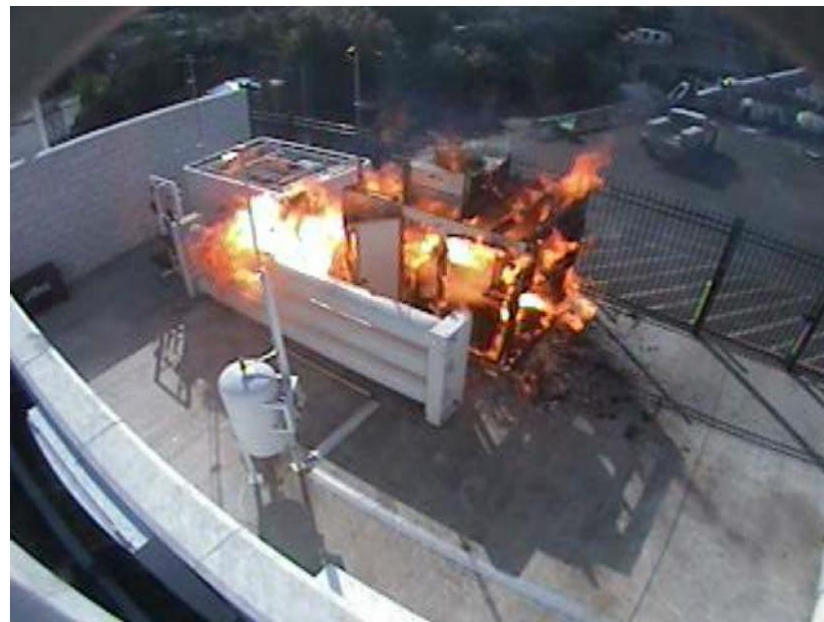
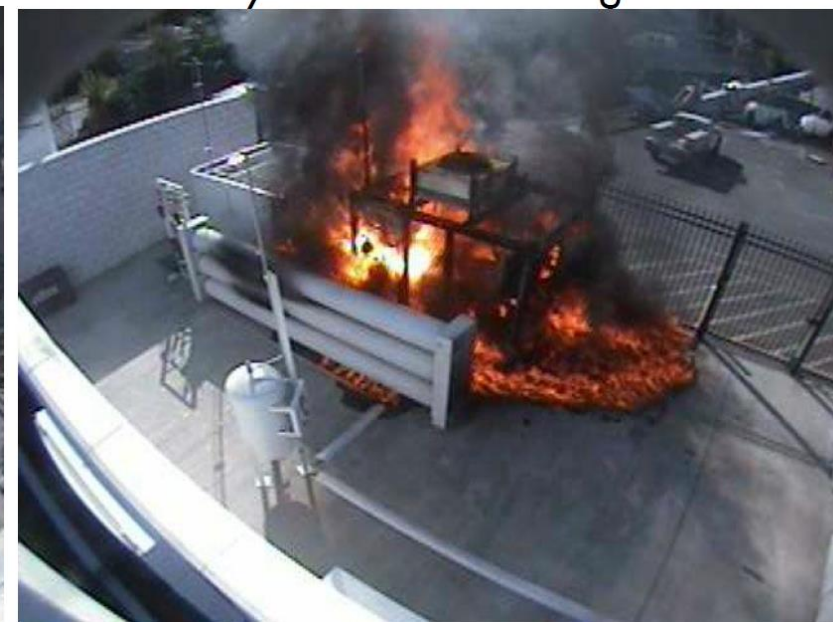
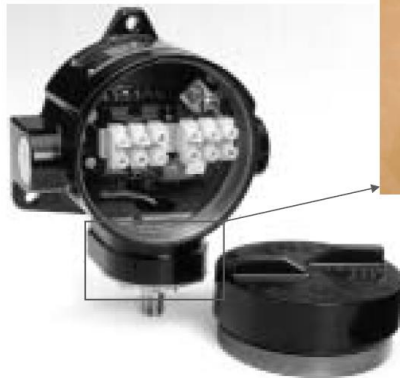
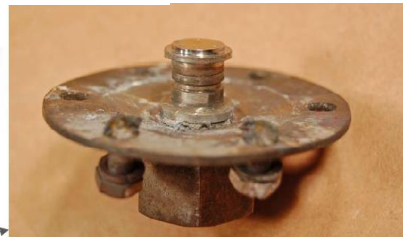
City of White Plains NY, USA – 21 August 2008

Pressure switch
PSH-104

- Increased scrutiny for selecting components (→ materials selection, welding)
- More robust design preventing escalation

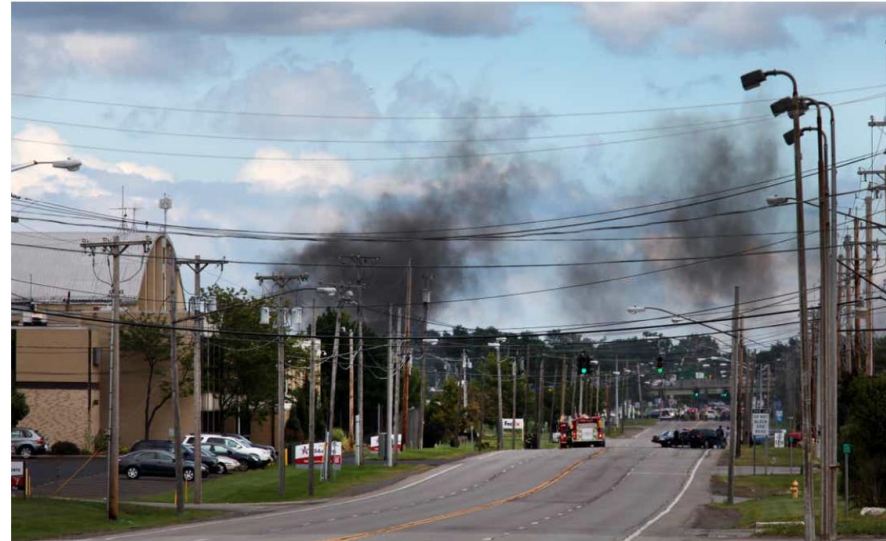
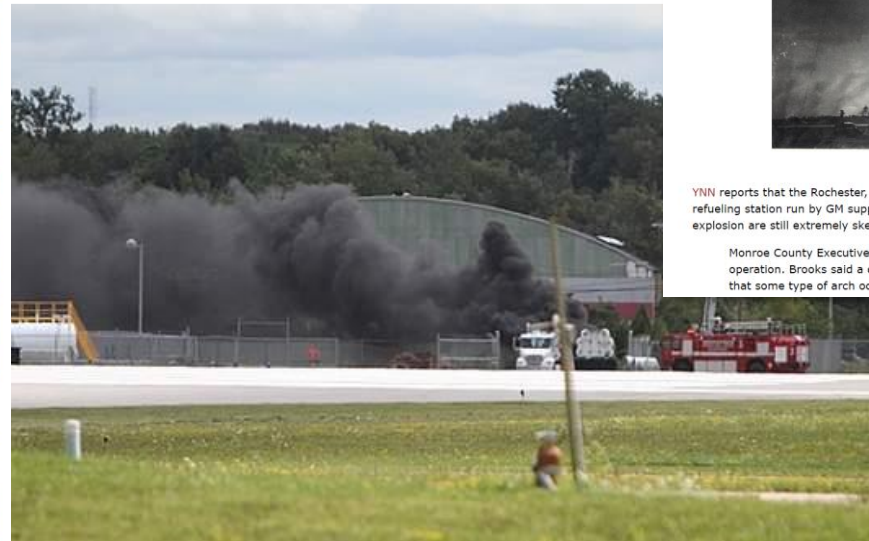
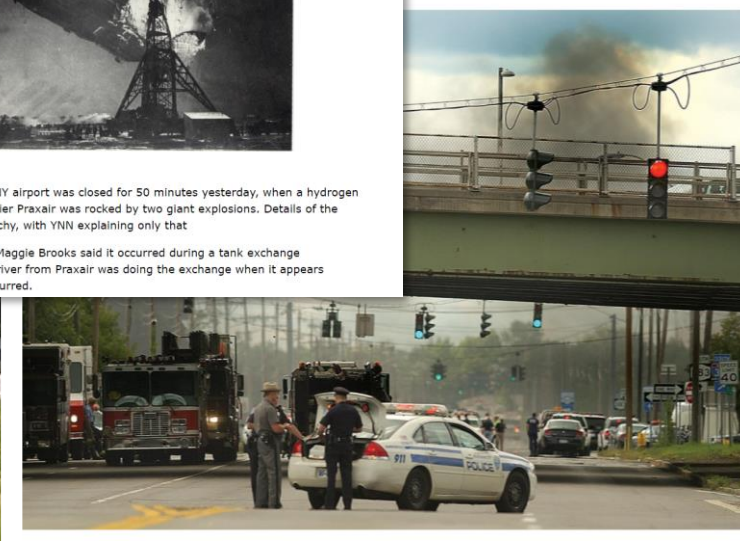
Rochester NY, USA – 26 August 2010

Monroe County Executive Maggie Brooks said it occurred during a tank exchange operation. Brooks said a driver from Praxair was doing the exchange when it appears that some type of arch occurred.

- Root cause unknown
- Escalation with trailered hydrogen
- Two injured persons

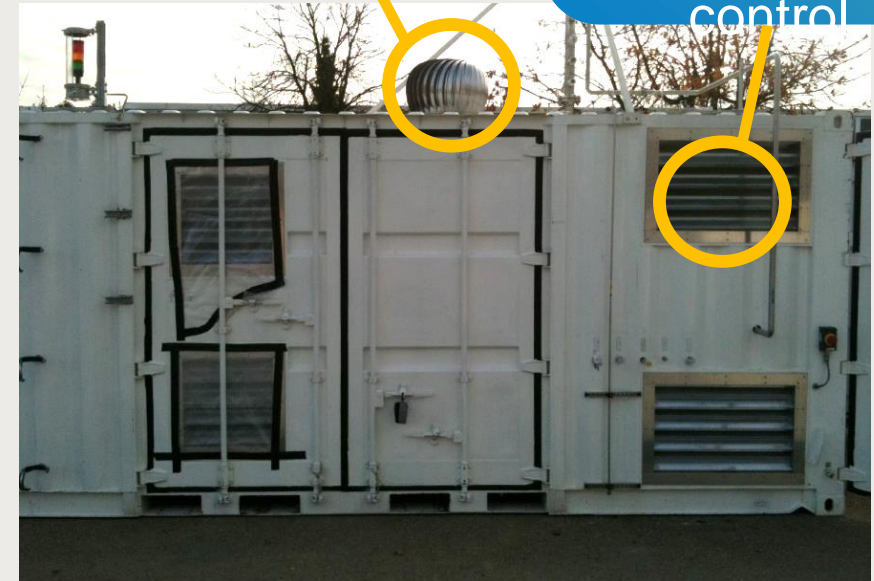
Rear side (northern) of compressor container

North American type ventilation system was considered as ignition source in EU (→ fixed)

Permanent forced ventilation outlet with instable flow control

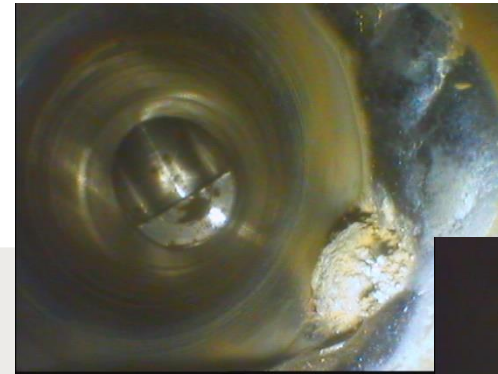
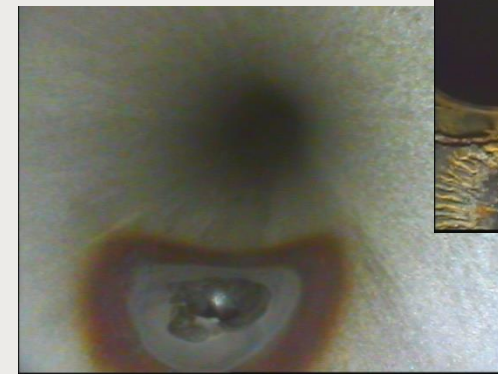
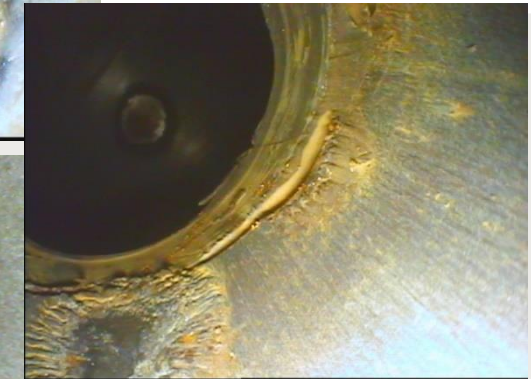
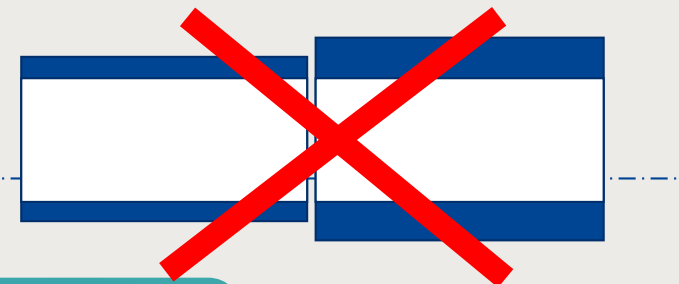
Visual inspection of connecting board pipes
14.02.2013

- Several weldings of high p piping proved to be defective in sample testing
- Several weldings of connecting board proved to be falsely designed, corroded or defective
- Pipe network connecting the high pressure vessels done wrong; tubes of different dimensions were welded face to face

Do careful statistical checks of weldings and control certificates and capabilities of suppliers

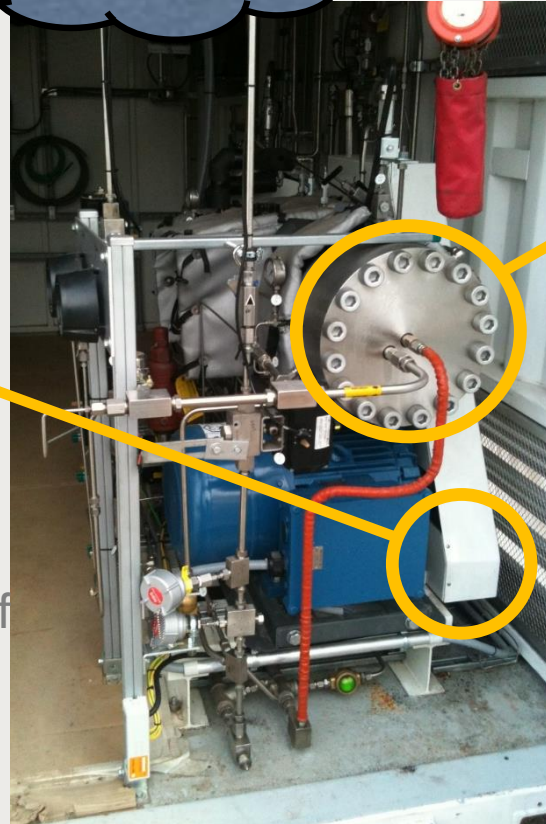
Installation QA failure (21.10.2011)

- Torque of the screws fixing the driving wheel on the motor shaft of the compressor were not checked

→
Driving wheel and belt ripped off during test refueling.
Emergency shut-down initiated manually.

Insist on full quality control, appropriate checks and prompt documentation of the installation procedures

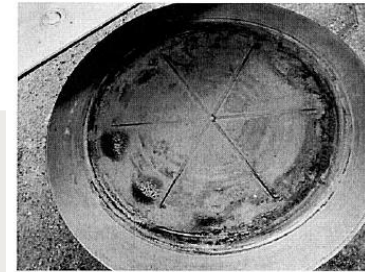
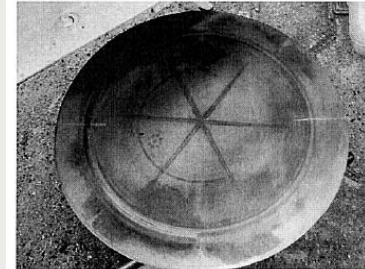
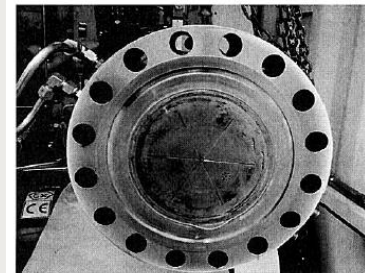
Installation QA failure (26.1.2012)

- Clamping of the compressor membrane was not mounted properly and not checked

→
Compressor indicated hydrogen loss; faulty installation was detected
Action:
membrane was replaced

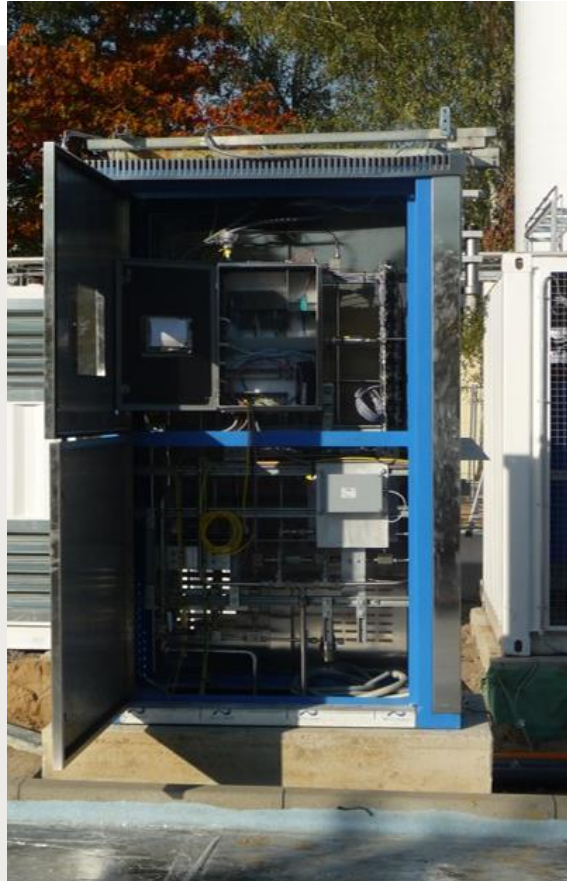
False Initial Installation of Seals (1.3.2012)

After additional checks seals were left for subsequent replacement in main yearly revision

Make sure your sealings are installed by capable staff and that leak tests are done appropriately; consider regular (weekly) leak tests

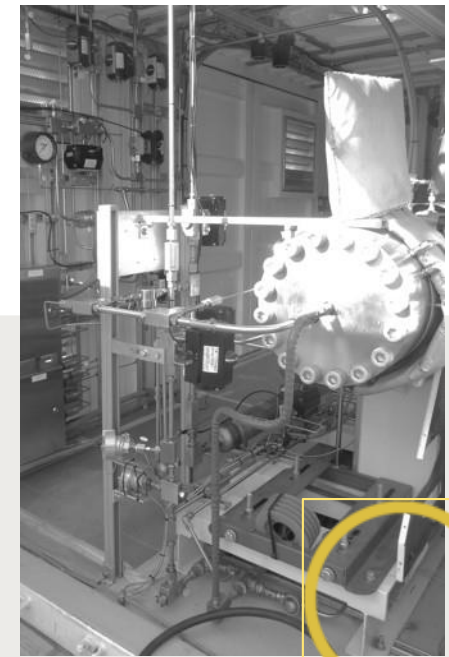
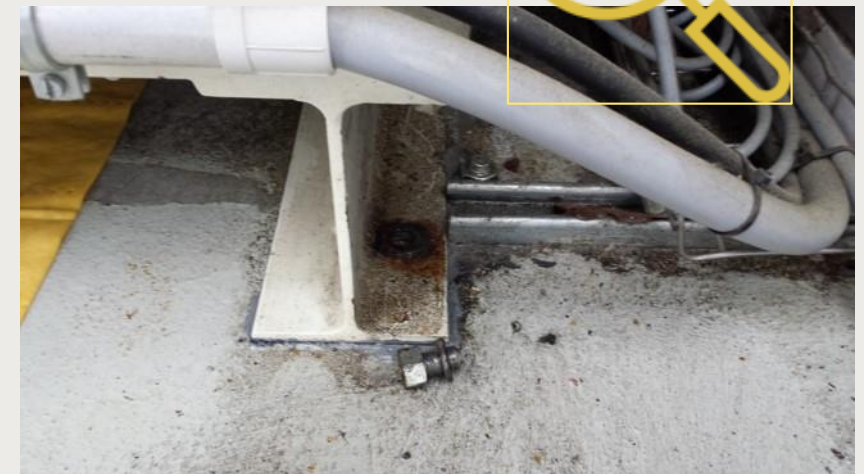
Anchor bolts of Compressor Skid Broken after 1 year operation (10.7.2014)

Incorrect foundation of the compressor led to strong vibrations

Several anchor bolts of the compressor skid found broken

- Foundation was changed (high costs) to reduce vibrations
- Regular control of vibrations and anchors was included in daily checks

Insist on well engineered foundation, check and control continuously vibrations and fixing of compressor skid (and other rotating machinery)
