FUEL CELLS AND HYDROGEN
JOINT UNDERTAKING

Case Studies – Ilford and Gangneung in South Korea History, Lessons learnt

Stuart Hawksworth

EHSP Workshop on Safety of Electrolysis
18th November 2020

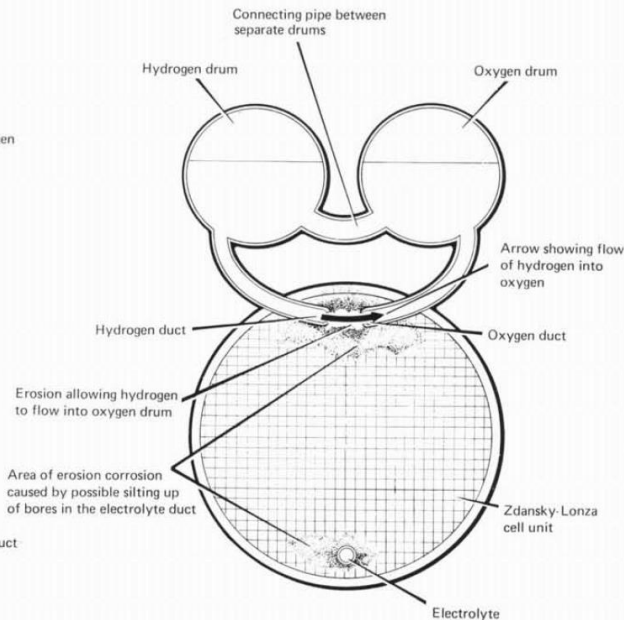
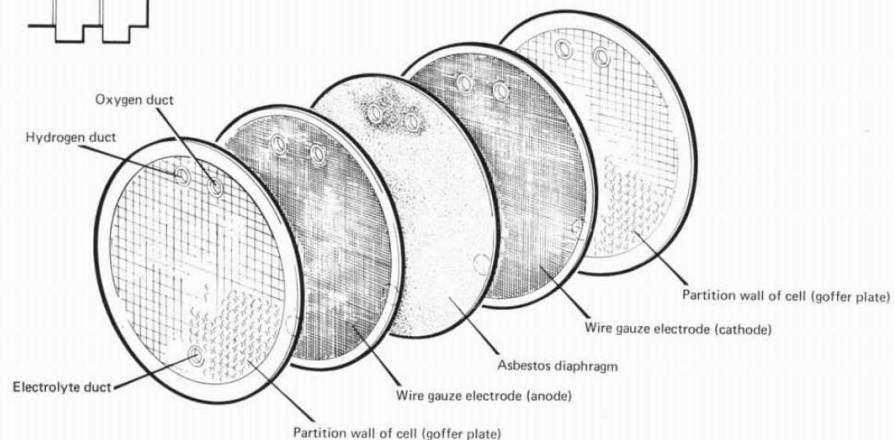
Diagram showing possible cause of explosion

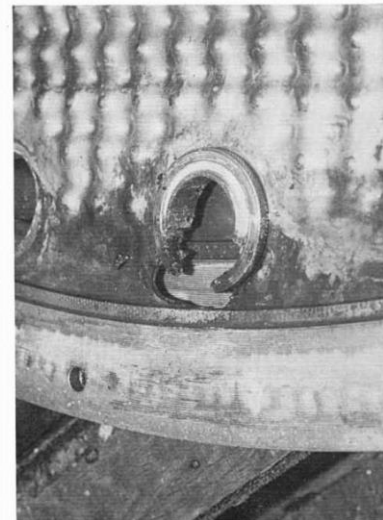
There was surface pitting of the plating on some of the goffer plates. (In some instances this had resulted in a hole right through the plate, fig 4.)

Fig 4 Perforated goffer plate

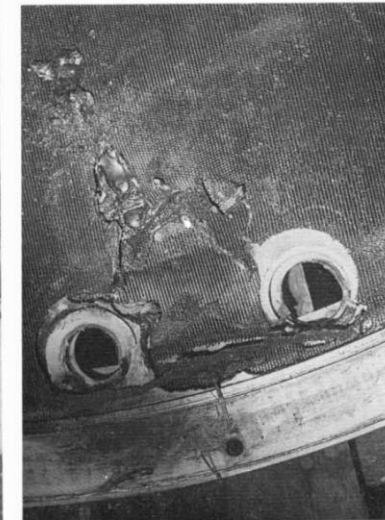
There was corrosion/erosion damage to some electrode gauzes with associated failure of the asbestos separators progressing to complete breakdown of the fabric of the cell, so that there was inter-connection between the hydrogen and oxygen ducts (fig 5).

Fig 5 Cell 16/3 showing damage to electrodes and asbestos separator

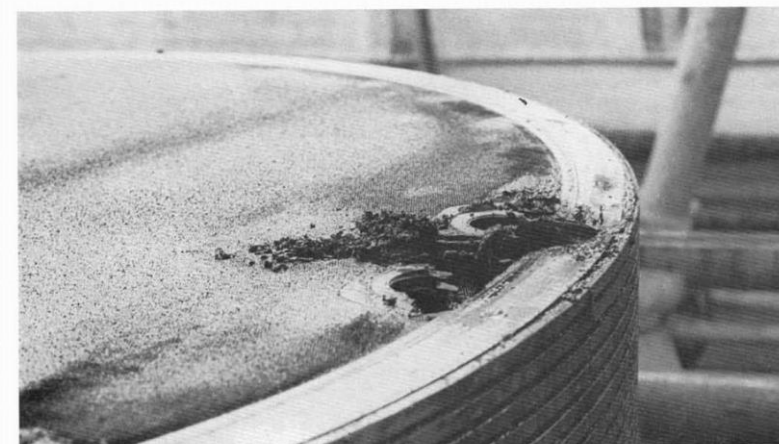
In one case (at the point where the electrolyte leak was observed on 2 April) the flange of the cell was eroded through to the outside (fig 6).

Fig 6 Cell 79 showing damage in vicinity of gas off-takes

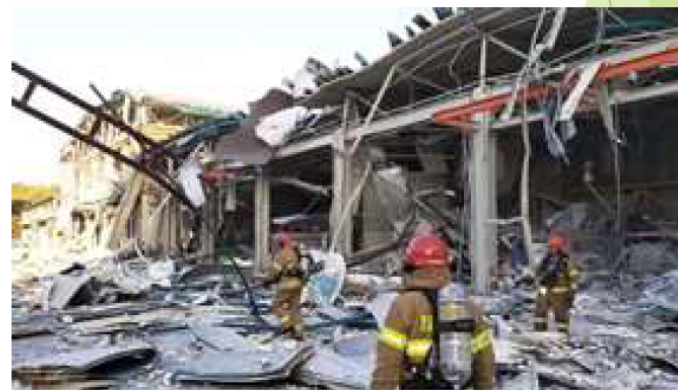
- **Event:** Explosion of an outdoor hydrogen gas tank at the research facility of a water electrolyzer coupled with a solar photovoltaic power system. (May 23. 2019) >>>
Two fatalities, six injuries, \$30 million damage
- **Cause:** Ignition of a H₂/O₂ gas mixture within the tank
 - The source of ignition was unclear between either auto-ignition or an external spark.
 - Potential membrane degradation may have led to excessive oxygen crossover through the cell membranes into the hydrogen gas produced.
- **Lesson learned:**
 - Understand interrelation of gas permeability of electrolyzer membrane, its degradation, and dynamic operating range due to fluctuating power level of photovoltaic system.
 - Secure automatic isolation of gas storage and emergency stop of gas production when safety limits are exceeded.
