**Analysis of
H2 related incident and
accident database
HIAD**

Thomas JORDAN
(Head of H2 Group of IKET/KIT)
Leader of Task Force TF1
European Hydrogen Safety Panel
EHSP

HRS Workshop H2ME

Den Haag, The Netherlands, 26 November 2019

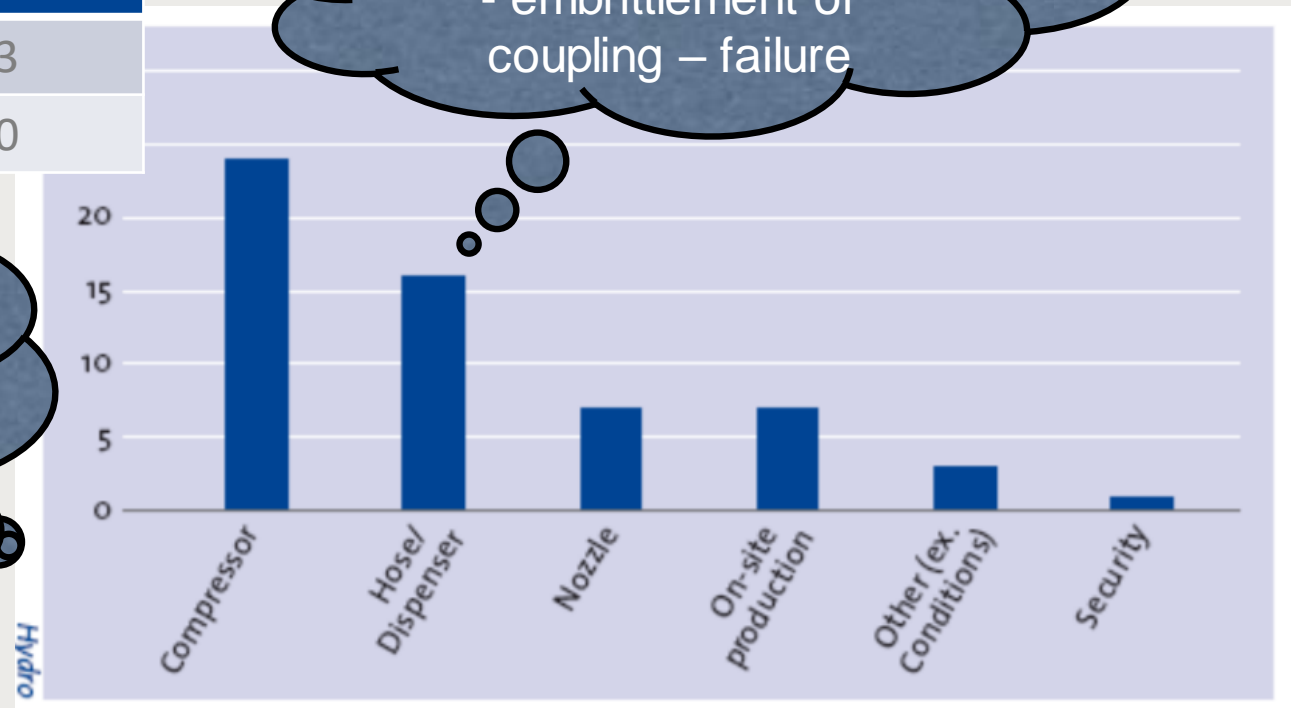
Incident ECTOSHRS Reykjavik:
Replacement of tube element – wrong material – erosion - release - fire

Incident Madrid HRS:
Wrong material selection - embrittlement of coupling – failure
