FUEL CELLS AND HYDROGEN
JOINT UNDERTAKING

Case Studies – Ilford and Gangneung in South Korea History, Lessons learnt

Stuart Hawksworth

EHSP Workshop on Safety of Electrolysis
18th November 2020

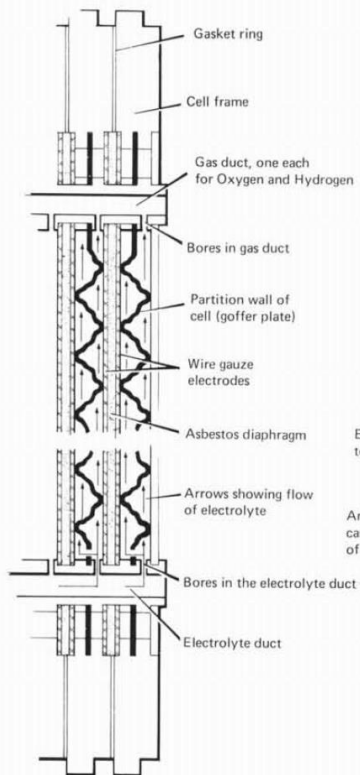
Section through Zdansky-Lonza cell

- Electrolysis is achieved in a "Zdansky-Lonza cell" containing two gauze electrodes. The cells are circular, about 1.5m in diameter and 25mm thick. (Appendix 3.) Application of an electric current to the electrodes causes the electrolyte to give off hydrogen at the cathode and oxygen at the anode.
