D2.2 - Test campaign on existing HRS & Dissemination of results

This document is the final deliverable of Tasks 2 & 3 of the tender N° FCH / OP / CONTRACT 196: "Development of a Metering Protocol for Hydrogen Refueling Stations".

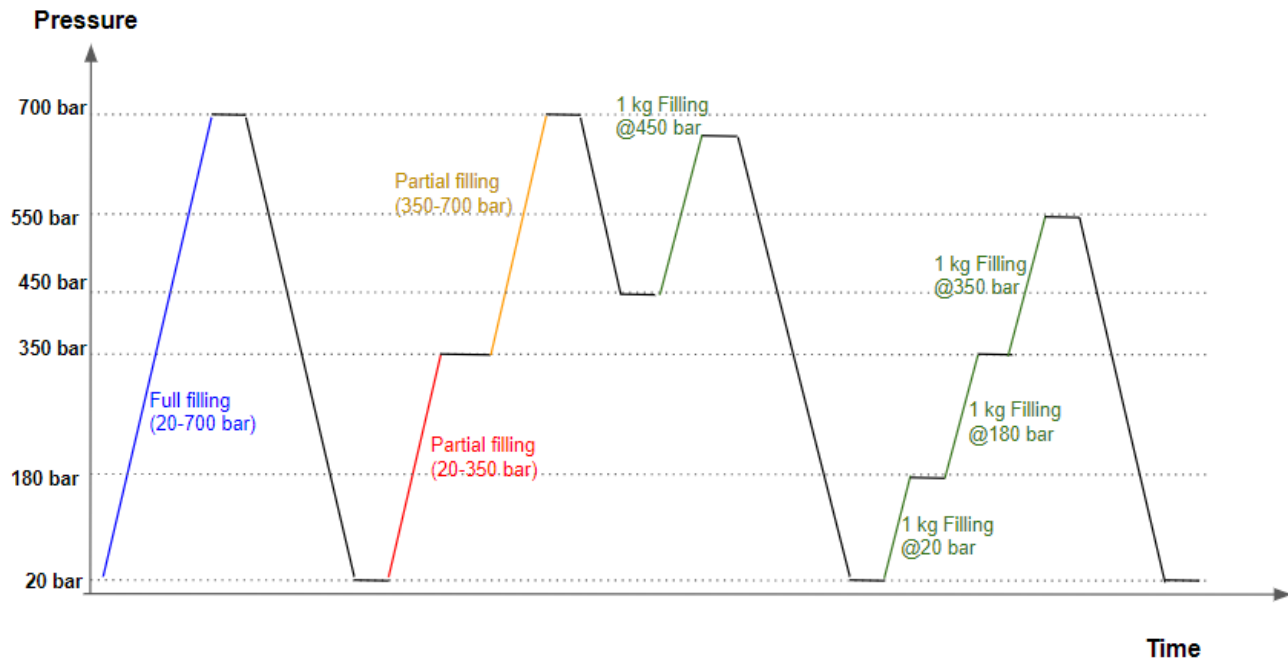
Figure 2: Sequence of tests performed 3-4 times per HRS

During the 3 days, it was possible to perform 3 to 4 times the following test sequence (see Figure 2), to get a good idea of the repeatability:

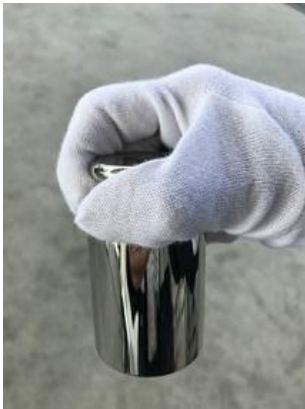
Figure 3: Calibrated weights handled cautiously with gloves

Each day of test, the scale was verified using reference weights of 1 kg / 2 kg / 2 kg (see Figure 3). This verification was done at the full range of the scale, i.e. when the empty cylinder was already in place onto the scale.

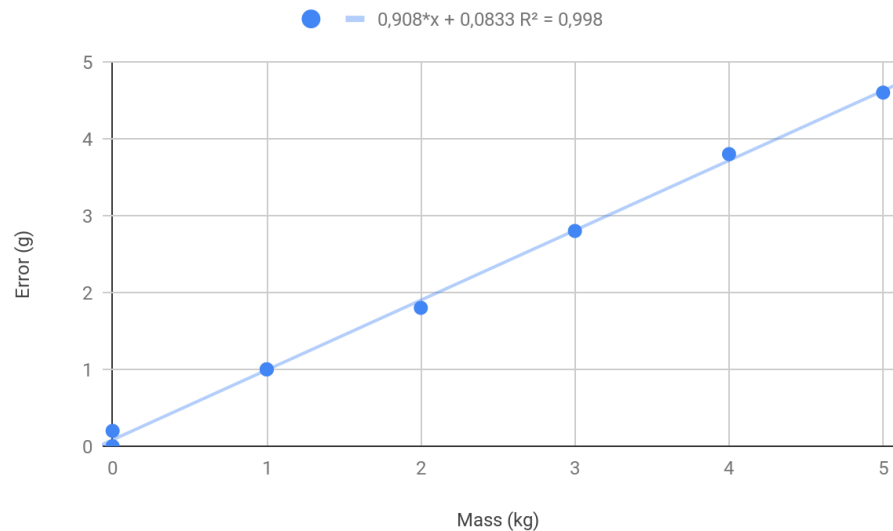
Figure 4: Example of scale deviation

Scale deviation was recorded and subtracted from the mass measurement for each day. The linear regression calculated (see Figure 4) is subtracted to each mass measured the same day of the scale verification.

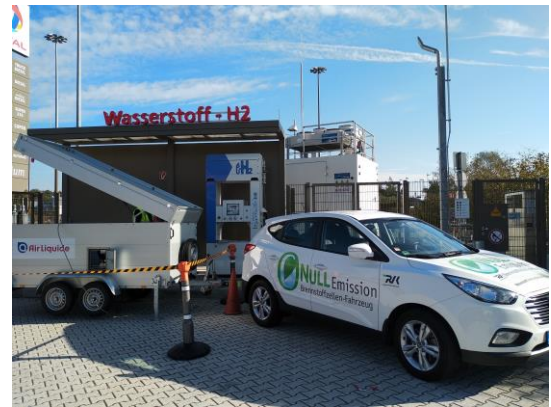
Figure 4: Installation at Cologne HRS

In Cologne: possibility to approach the dispenser in going backwards, manoeuvre mandatory. One H2 vehicle came to refuel during the week.

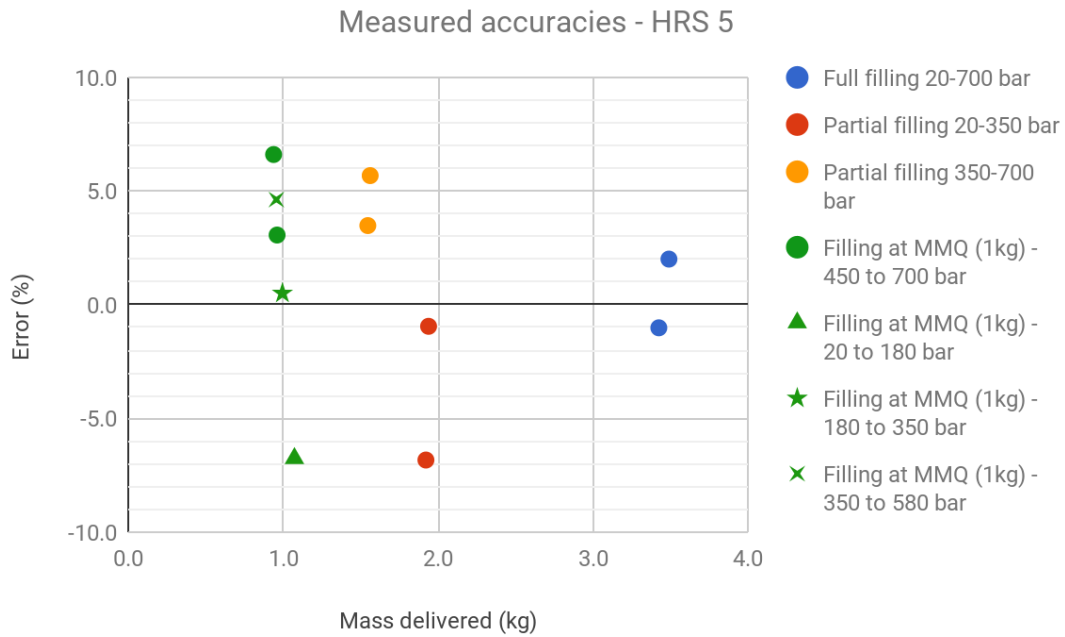
Figure 14: Results of accuracy tests in HRS 5

A non negligible scatter has been observed on this station. But the tendency of tests results looks similar to previous HRS.

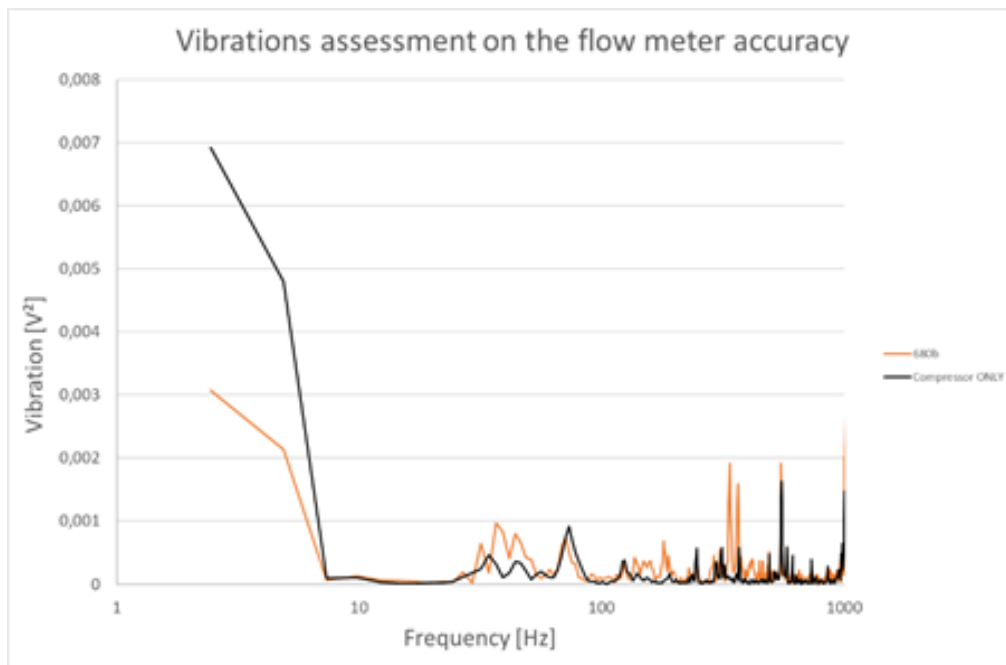
Figure 21 : Vibrations assessment on the CFM - HR2

During filling, the MFM does not encounter any large vibrations. When the compressor was running, the related frequencies remained low (below 10 Hz). No bias has been found regarding vibration perturbations in this study.
